Ensayos No Destructivos
en la Ingeniería Civil
CAI - 10/Agosto/17

SENSORES PARA EL MONITOREO NO DESTRUCTIVO DE LA CORROSIÓN DE ARMADURAS EN ESTRUCTURAS DE HORMIGÓN

Gustavo Duffó

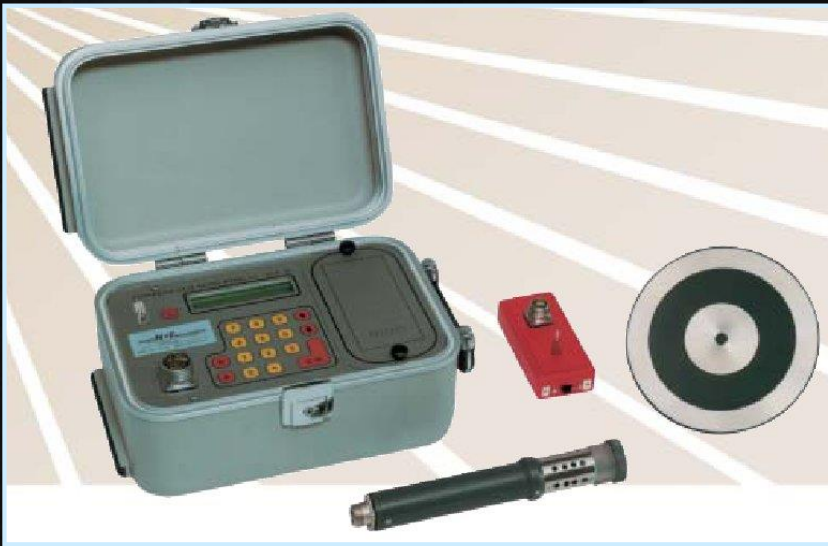
Mediciones desde “afuera” de la estructura

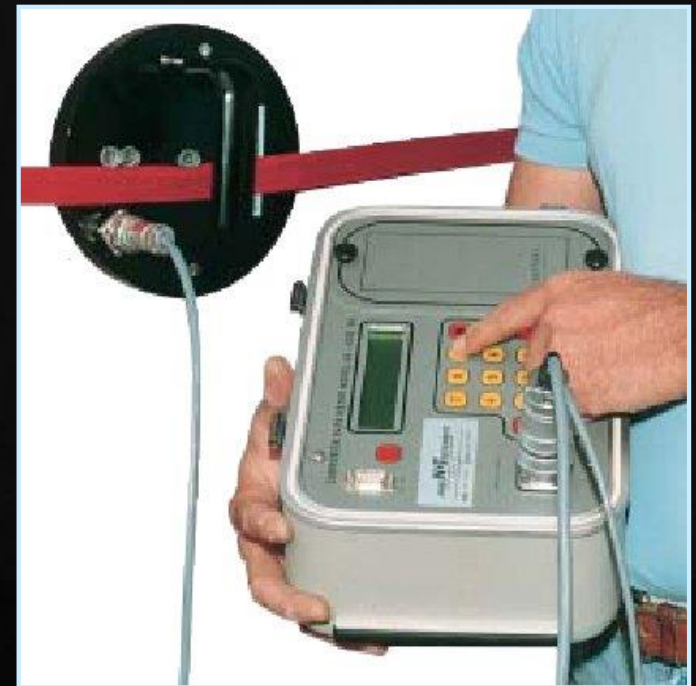
Gecor – 6

- * E_{corr}
- * V_{corr}
- * Resistividad
- * Temperatura

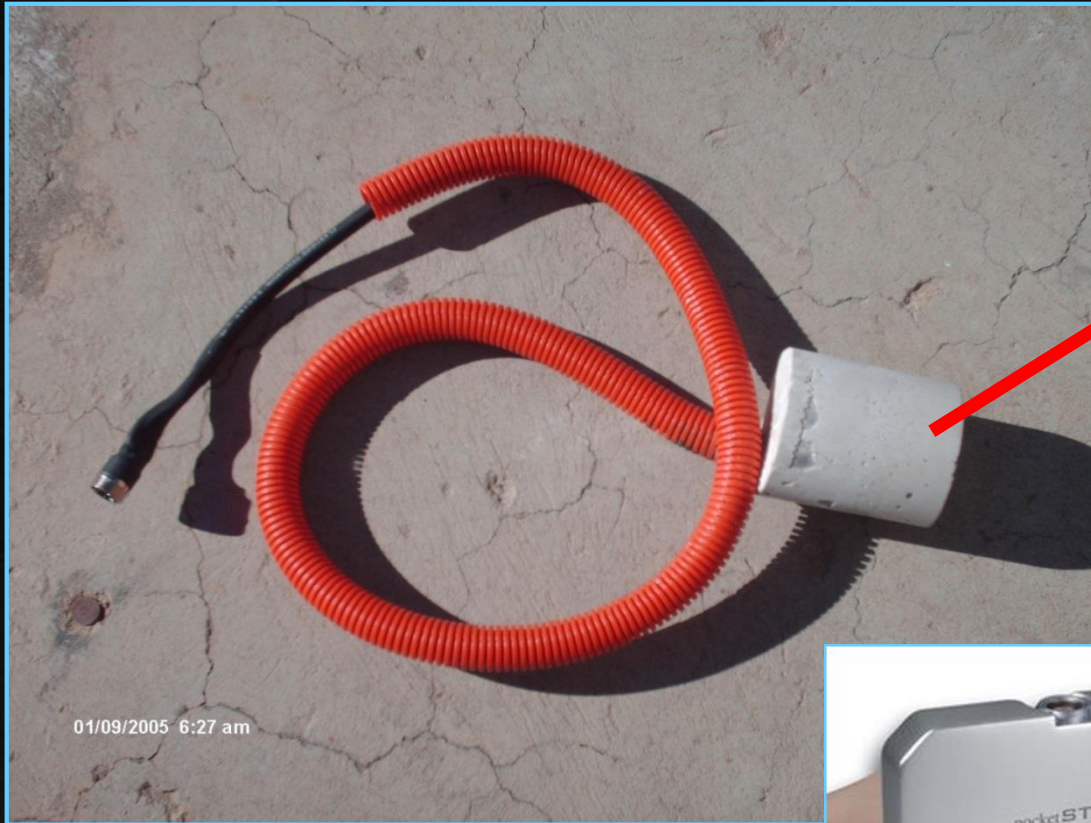
SENSOR LISTO PARA INSTALAR

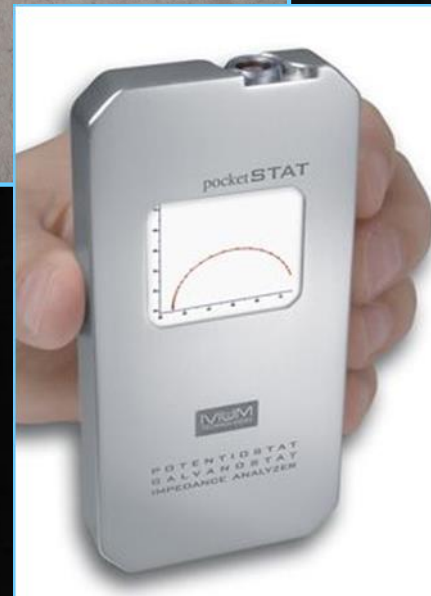
Electrodos embebidos

- * E_{corr}
- * V_{corr}
- * Resistividad
- * $[\text{Cl}^-]$
- * O_2
- * Temperatura

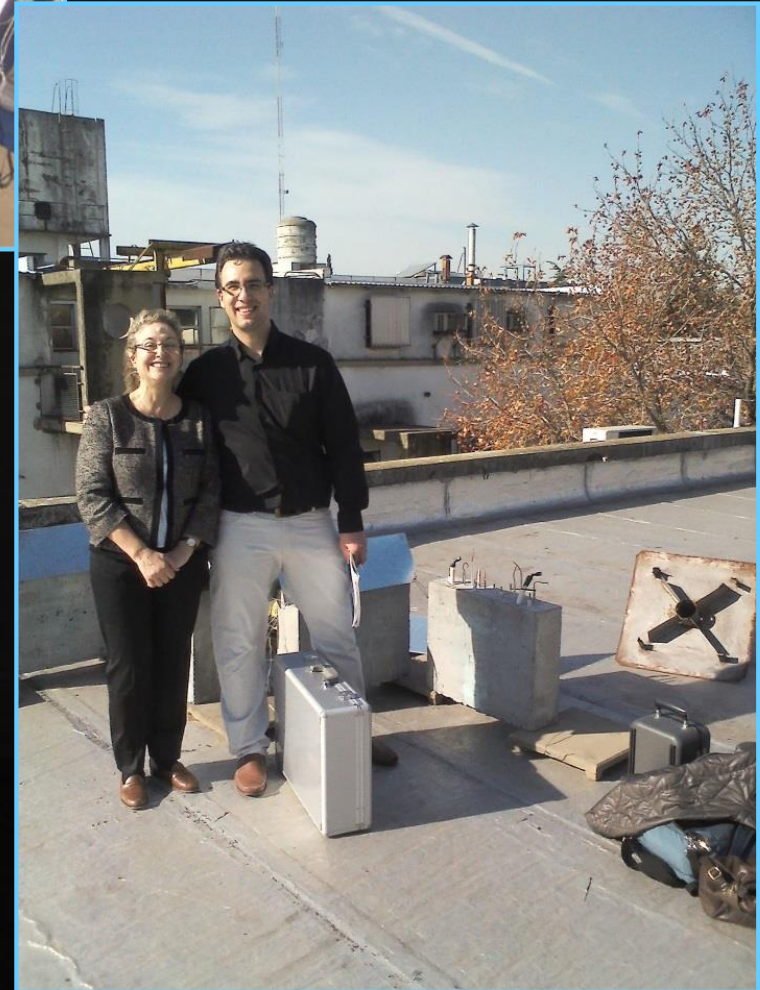
- GECOR 6
- Sensores
- Armaduras (barras y mallas), contraelectrodos de acero inoxidable y electrodos de referencia internos
